1985 Townwide Historic and Architectural Survey of Berlin, Connecticut. Survey # 065

HISTORIC RESOURCES INVENTORY
BUILDING AND STRUCTURES
 HIST-6 NEW 5/77

IDENTIFICATION	
1. BUILDING NAME (Common) _____ (Historic) _____	
2. TOWN/CITY Berlin	VILLAGE _____ COUNTY Hartford
3. STREET AND NUMBER (and/or location) 181 Hudson Street 16-1/102/54

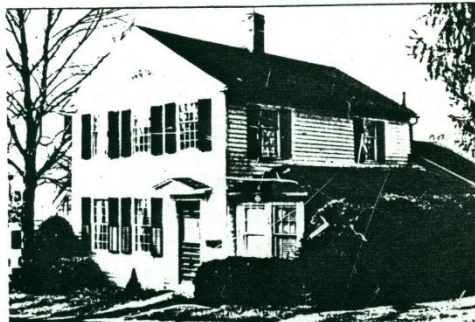
COMPILED BY PHOTO

This small house has a three-bay facade with the entry on the right underneath a later peaked hood. The entry has molded pilasters and a lintel with paneled corner blocks; the entry door is later, and has one large light over panels. Windows have plain board surrounds and are fitted with old 12-over-12 sash. There is a small triangular attic light and a partial return of the molded cornice. On the right is a one-story framed-in porch. A barn at the rear of the property has a Victorian frieze with applied half-spindles in place of brackets.

This house is significant as a good, well-preserved example of an early 19th-century vernacular house. Showing the gable-to-street orientation that first became common after 1800, the house retains the characteristic clapboarded siding and four-ranked small-pane sash. The triangular attic light is a modest attempt at Federal decoration, suggesting the contours of an attic fanlight.
